### Escape of Water at High Net Worth Property

In July 2016, Revival South-West London was instructed to assist with the trace and access of a leak at a large detached property in Kingston-Upon-Thames, Surrey where the insured had discovered damp patches on the garage wall.

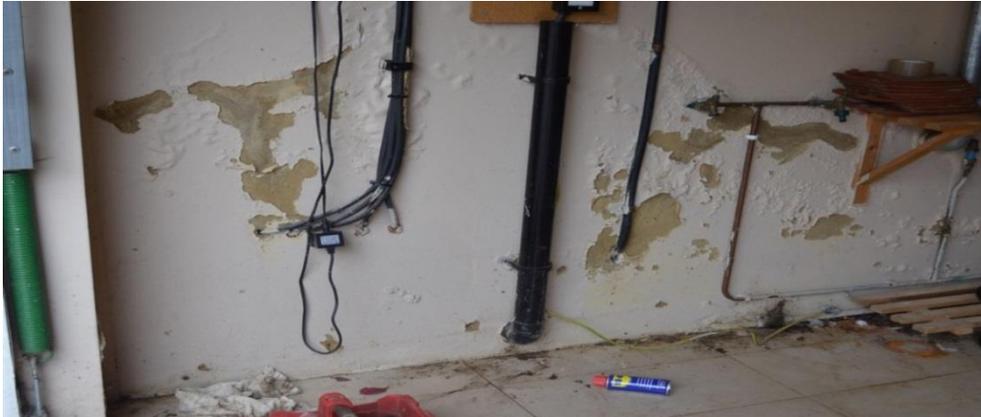
When our technicians attended the property, they discovered the left side of the wall had heavy water damage on the render, which had blown and showed salts contamination. There was also evidence of layers Damp Proof Membranes on the outer wall.

The water was found to be escaping from the coupling on the copper side of the blue mains feed pipe as it appeared to have been cut slightly too short to gain the right grip.

When the leak was repaired, the water was re-engaged and tested for 30 minutes. After that, the leak was confirmed to have stopped and the water metre stationary.
