1920s – 1930s Mock Tudor House

On 28th April 2016, Revival East Anglia were called out to a 1920s – 1930s mock Tudor house with high-end furnishings and Wilton carpets throughout. We were notified to carry out a Leak Detection/Trace & Access job for a suspected leak on the central heating system due to regular drops in pressure.

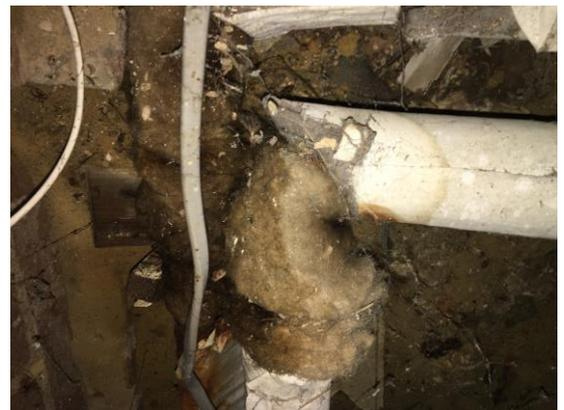
Source pipe with possible ACM

A potential ACM (Asbestos Containing Material) was discovered in the form of pipe insulation. Potential ACM was encapsulated to lock down any potential asbestos fibres. A sample of the insulation was taken for lab analysis and the results were received within 24 hours.

The results were negative, which gave us the all clear to proceed with repairing the leaking pipe.

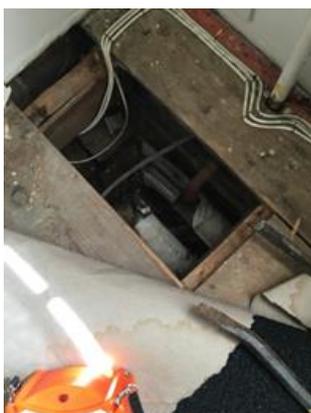
The central heating system was completely drained down and the system was filled with traceable gas. After a few hours an EOW was detected in the Study.

Contents were then photographed prior to removal in order to access the leak beneath the floor. A small section of floor board was removed to view the pipe work and the leak location was confirmed.

Accessing the pipe in the corner of the Study
